MAPLE LAKE DAM

NDI ID NO. PA-00294

PENNSYLVANIA GAS AND WATER COMPANY

PHASE I INSPECTION REPORT  
NATIONAL DAM INSPECTION PROGRAM

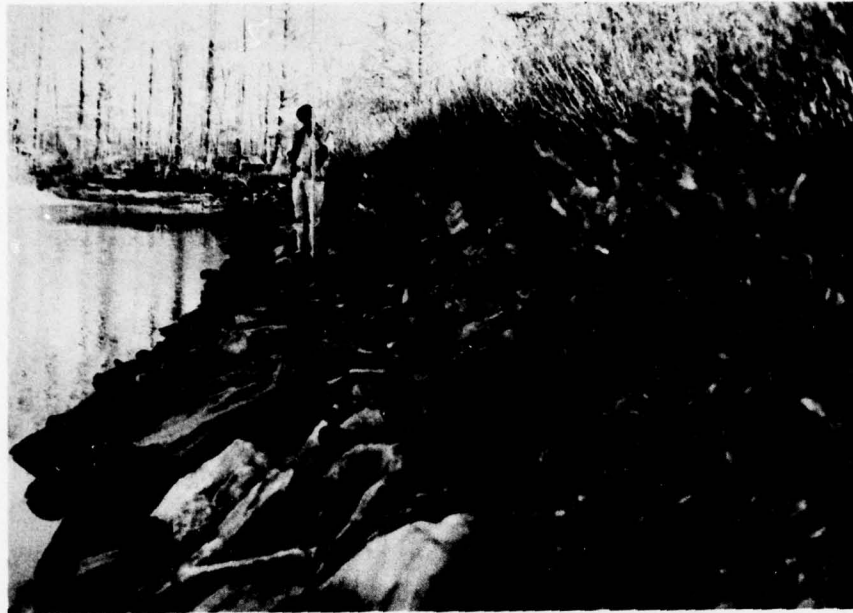
(2) Embankment. Brush and trees on the embankment slopes or at the toe are undesirable. The failure of the dry masonry wall and the accompanied embankment slide at the top of the dam along the upstream slope is of major concern. The embankment sliding behind the wall indicates that the failure of the wall was a shear type failure. The slide surface is relatively fresh in some areas indicating that movement was relatively recent. It was not possible to determine if the failure was a shallow shear failure or a deep-seated shear failure, however, the failure appeared to be a shallow shear failure. Because of the slide in some areas, the top width of the embankment is only about 4 feet wide. Where the dry masonry wall failed, there is no upstream slope protection at the top of the dam. A review of photographs in the PennDER files shows that the top of dam was approximately level in 1914. Subsequent photographs and Plate 2 show that failure of the dry masonry wall and accompanied embankment failure has been occurring over an extended period. The downstream slope is steeper than the design slope listed in the Pennsylvania Water Supply Commission Report of 1914. The steep downstream slope may be related to the bulges observed at the toe. It was not possible to determine if the wet areas and seepage at the downstream toe of the slope were related to seepage from the embankment or to poor surface drainage.

C. Upstream Slope of Embankment.

(1) Perform additional studies to determine the extent of movement of the embankment and to ascertain the structural factors of safety for the embankment. In this regard, additional investigations will be necessary to determine the engineering soil properties of the embankment and the foundation, as well as the location of the water level in the embankment. The latter may be accomplished with the observation wells recommended below. Take remedial measures as required to restore the embankment to either its original template or a more suitable template.

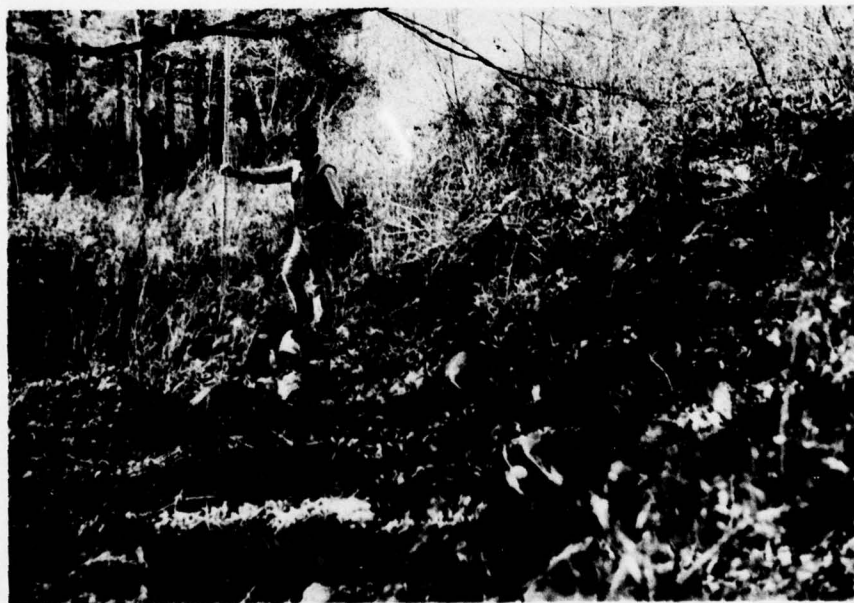
D. Downstream Toe.

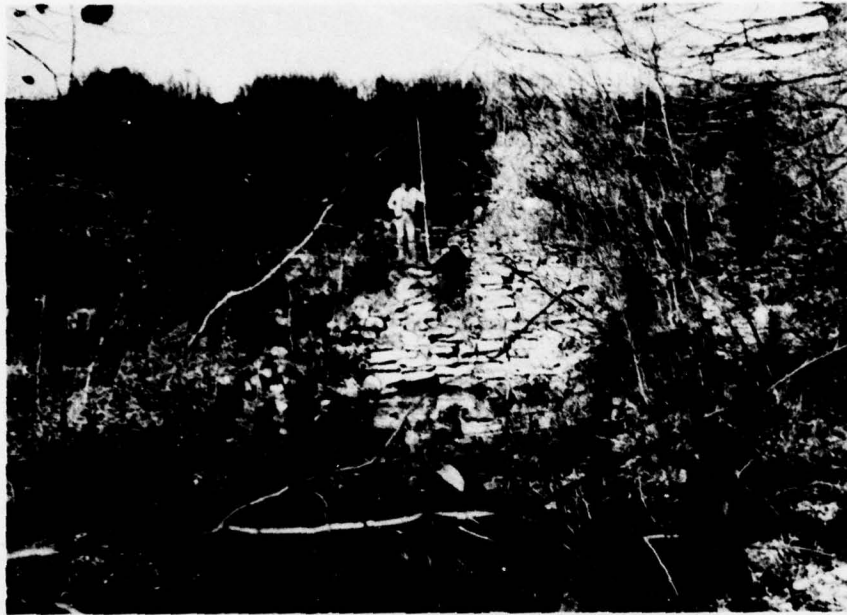
E. Outlet Works

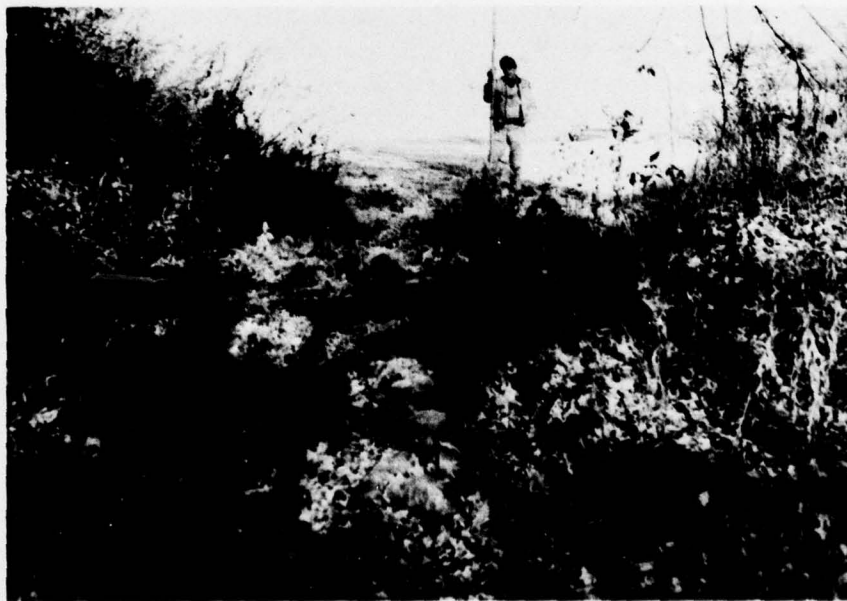
c. Appurtenant Structures. The spillway is in poor condition. The spillway control section is poorly defined. The timber spillway weir is rotted and collapsed. The spillway outlet channel is severely eroded, especially along the right bank. There is also some debris in the channel. The outlet works is in good condition; however, most of the outlet works could not be viewed. The operating platform was constructed with dry masonry, which abut the embankment on 3 sides. On the day of the inspection, the outlet works valve was partially open; water was being released into Rattlesnake Creek. The end of the pipe is beneath the dry masonry operating floor ledge. The end of the pipe could not be inspected or measured. The valve stem protrudes through the operating floor. There did not appear to be any means of access to the valve without removing the dry masonry operating floor.

F. Spillway - Looking Upstream.

(2) Perform additional studies to more accurately ascertain the spillway capacity required for Maple Lake Dam as well as the nature and extent of mitigation measures required to make the spillway hydraulically adequate and to remove the erosion hazard. Designing the dike to be overtopped may be a suitable approach, but the spillway should be provided with a weir and the spillway channel should be protected against erosion.

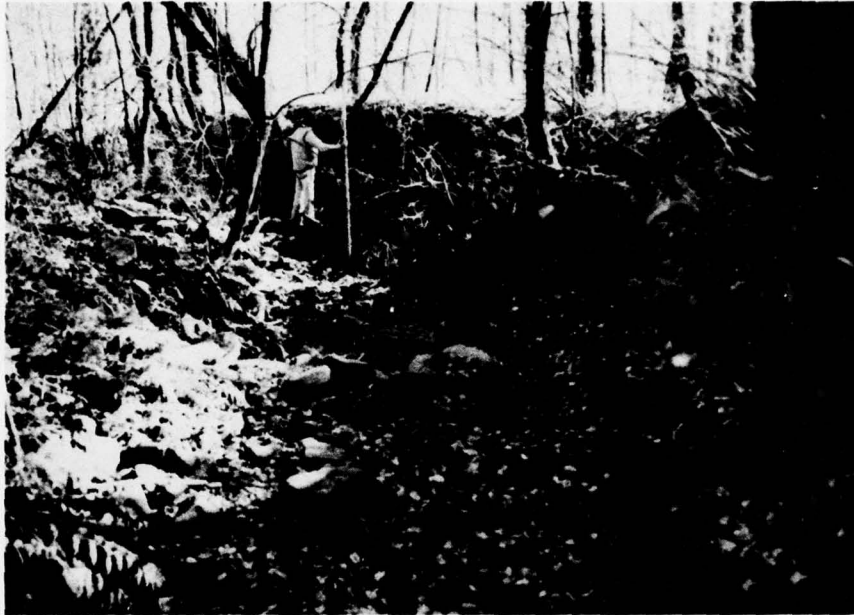
G. Spillway Outlet Channel - Looking Downstream.

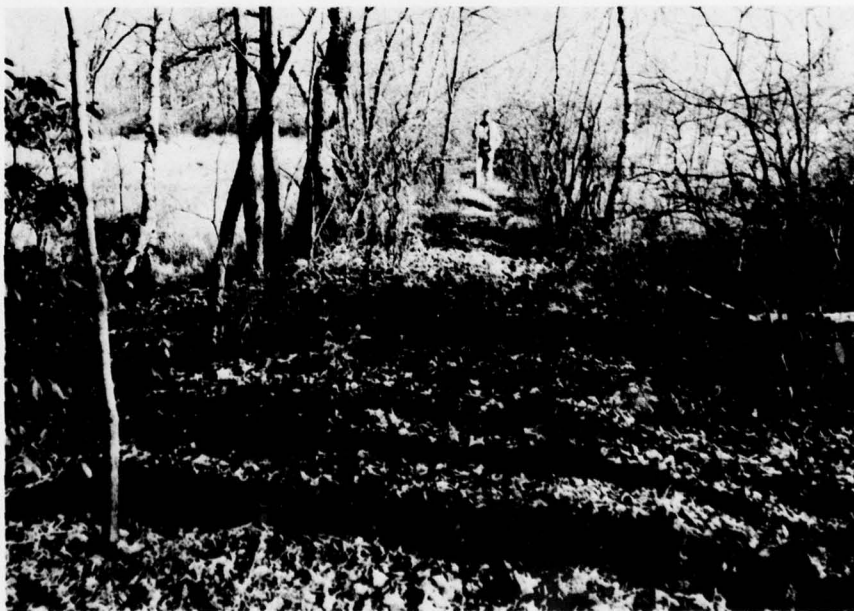
Brush and trees on the dike are undesirable. The uneven top elevations on the dike are probably caused by poor construction practice.

H. Dike - View from Left Abutment.
